ENGINEERING CASE LIBRARY

## THE BUMBLING BUS (A)

This case history describes a bus and automobile accident on a snowy day with gusty winds. Analysis of the situation involves rigid body dynamics with some fluid mechanics relating to drag forces on the bus due to winds.

Preliminary Report

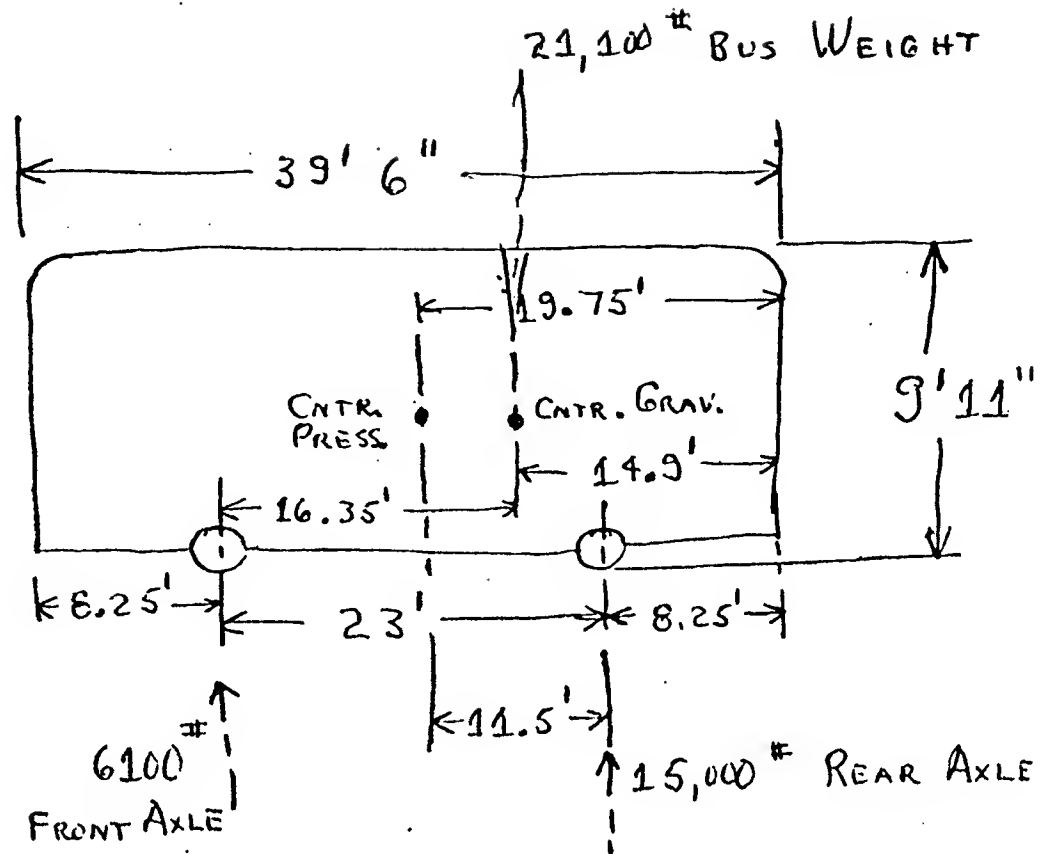
FIGURE 1.

The following has been prepared on the bases of a report by Mr. H., the police report of the incident, and a letter from the Weather Center. I have assumed that the dimensions and weight of the bus given by Mr. H. are correct. This information is summarized in Figure 1.

SCHEMATIC SIDEVIEW OF BUS

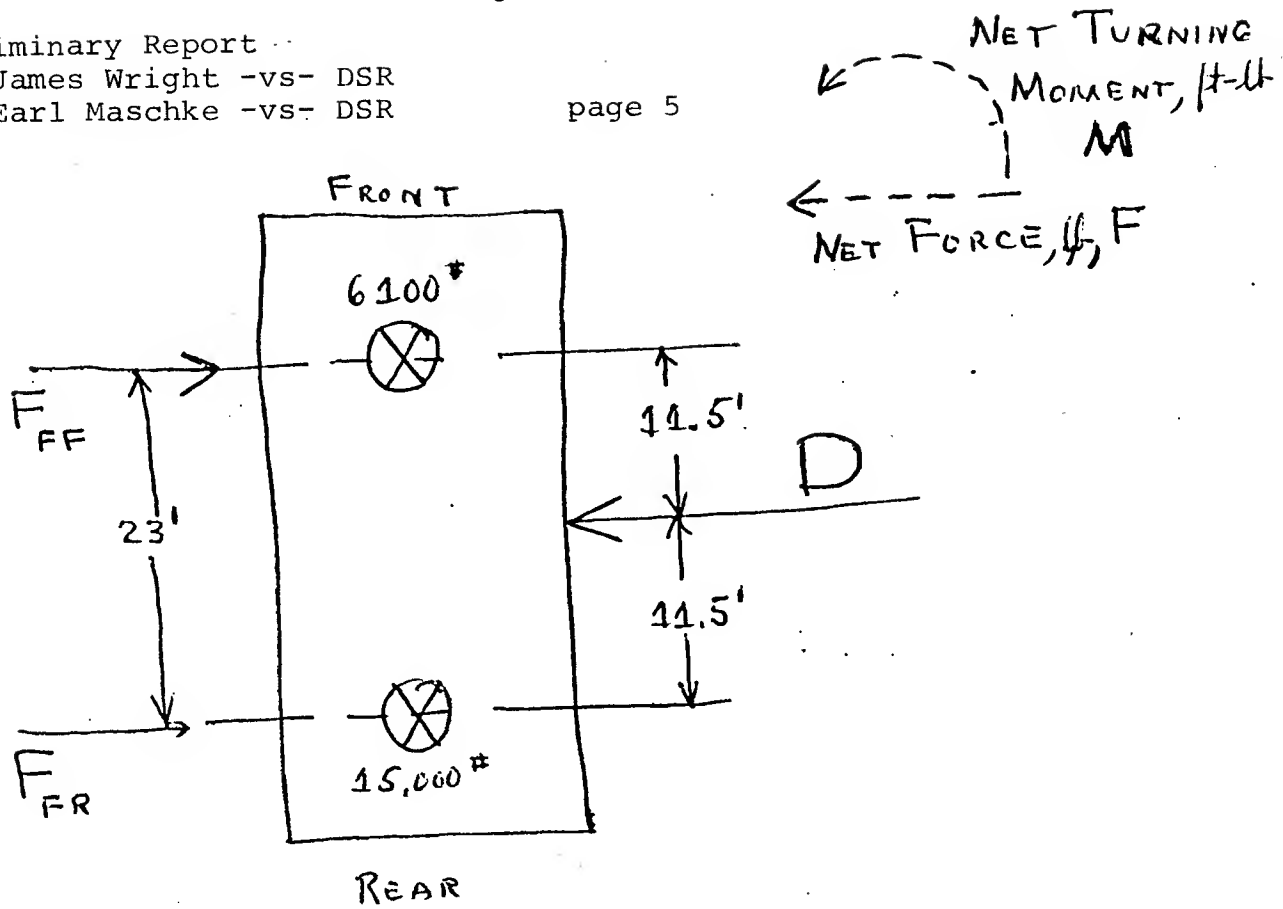
FIGURE 2.

Figure 2 shows a schematic top view of the bus with the effective location of the drag force shown. The tires on the roadway will develop a resisting frictional force opposing motion or impending motion. If no force is applied, no frictional force is developed. The maximum frictional force which can be developed is limited by the coefficient of friction (the ratio of the resisting force to the force normal to the plane of motion, i.e., the weight). For rubber on ice, the coefficient of friction can vary from 0.05 to 0.20 or 0.25. If a coefficient of friction of 0.05 is used, then the maximum frictional force which the front wheels can exert is 305 lb. while the rear wheels can exert a maximum frictional force of 750 lb.

If the drag force exceeds the sum of the two frictional forces, there will be a net force acting as shown at the top right hand corner of Fig. 2. A net turning moment can also be exerted as shown in the top right hand corner of Fig. 2. If there is a net sidewise force, the bus will tend to move (slide) to the left. If there is a net turning moment, the bus will tend to rotate and thus turn to the left.

It is my opinion that use of a wind speed of 40 mph and a drag coefficient of 0.46 is appropriate. When used in conjunction with the smallest probable coefficient of friction, the net sidewise force is zero and there is a net turning moment of 1500 ft-lb. This would tend to turn the bus to the left but with the inertia of the bus, this would represent a very slow turning. If a wind speed of 50 mph is used with the same coefficient of friction, there is a net sidewise force of 95 lb and a net turning moment of 6200 ft-lb. These would tend to slide the bus to the left and cause it to turn to the left. While this turning would be somewhat more rapid than with the lower wind speed, this would still be a slow turning. Even if one were to adopt the drag coefficient of 0.70 used for automobiles, with a wind speed of 50 mph, there would be a lateral acceleration of about  $1 \text{ ft/sec}^2$  (about  $1/30$  of the acceleration in a freely falling object) and a rotational acceleration of less than  $8^\circ/\text{sec}^2$ .
